LIGHTNING MASTER VENT STACK HALO SYSTEM

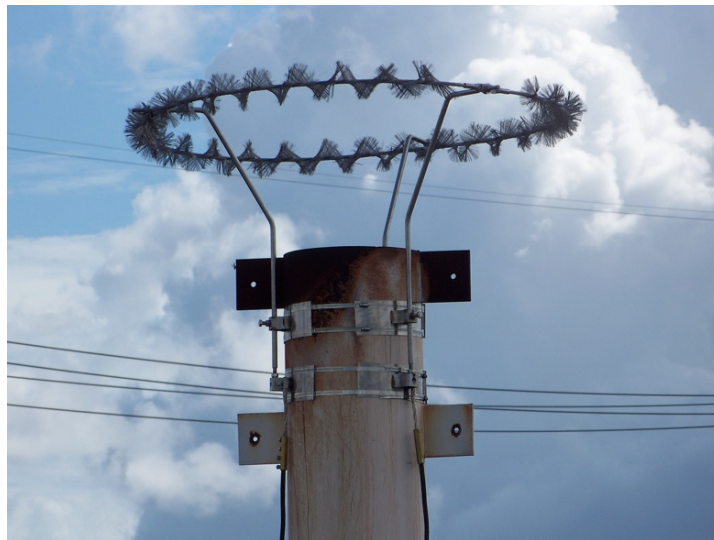
Based upon the configuration of the stacks, we modified one of our existing products, an appliance designed in the mid-1980's to be part of a lightning protection system for tall broadcast towers. The stack system consists of a halo resembling Christmas-tree garland around the top of the stack, electrical bonding of potential spark producers, and grounding. The main conductor consists of a 316 stainless steel cable with small electrode wires inserted through it. The wires are available in 316 stainless, titanium or Hastelloy, as dictated by the environment in which it is installed. The mounting system holds the halo outboard of the stack, and reliably supports the halo throughout high winds and plant vibrations. In the case of static, the halo acts to neutralize static charges. In the case of lightning, it acts to conduct current and equalize potential.

Static on the stack also allows micro arcing between any irregularities or gaps in the stack. If flammable gas is present, it may ignite. We also generally run a crisscross of conductive wire or metal bar stock across the mouth of the stack where an arc could otherwise occur. The combination of the halo around the stack perimeter and the crisscross bonding has proven very effective at controlling stack ignitions.
